AR 15-6 Investigation

Operation Cnoctaw

Non-Combatant Death

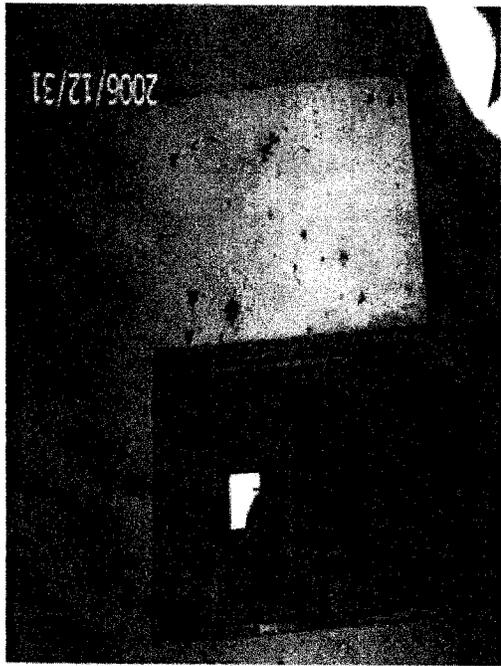
Interior - looking into kitchen area

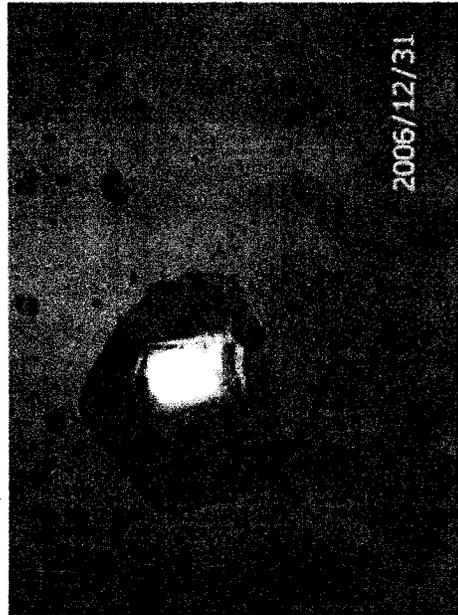
• 1 x [redacted] (2)Hi round impacted house #10, location C [redacted] (2)Hi. The round struck the roof of the house, penetrated, and detonated on the floor. The fuse was set on delay.

Entrance of round through Roof
