SUBJECT: Electrical Shock Incident Investigation

INCIDENT REPORT #: 200912011500

SITE: F.O.B. Falcon (D4)

FACILITY I.D.: 750 PAX LSA Area – ( next to C.H.U.# – 16K)

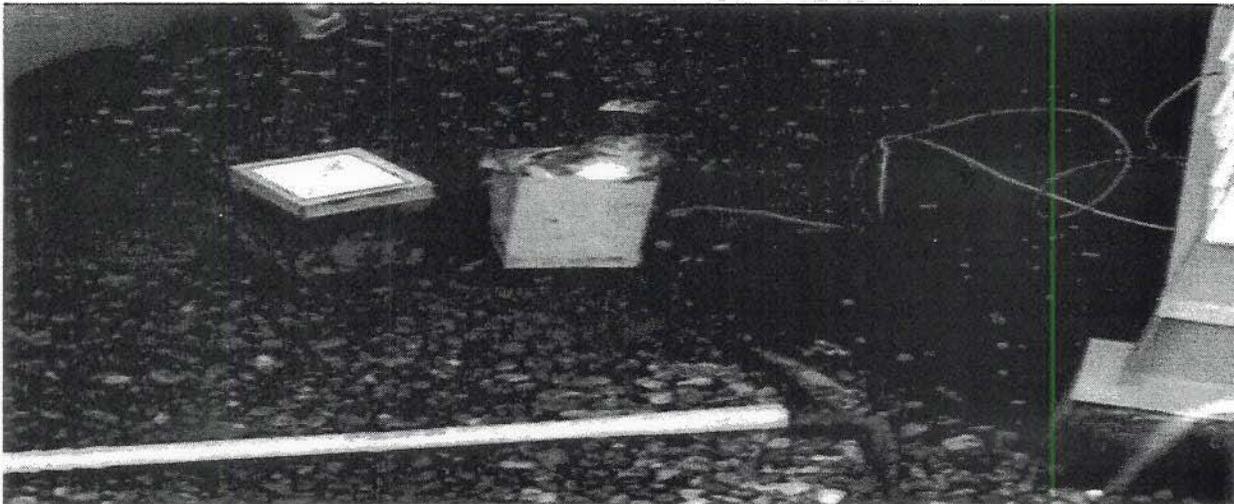
The incident site as found when the Task Force Safe team arrived. 12-Jan-2009 1530

The investigation into the incident started at approximately 1530. The photo above shows the area where the incident occurred. To our knowledge, nothing had been disturbed prior to our arrival.

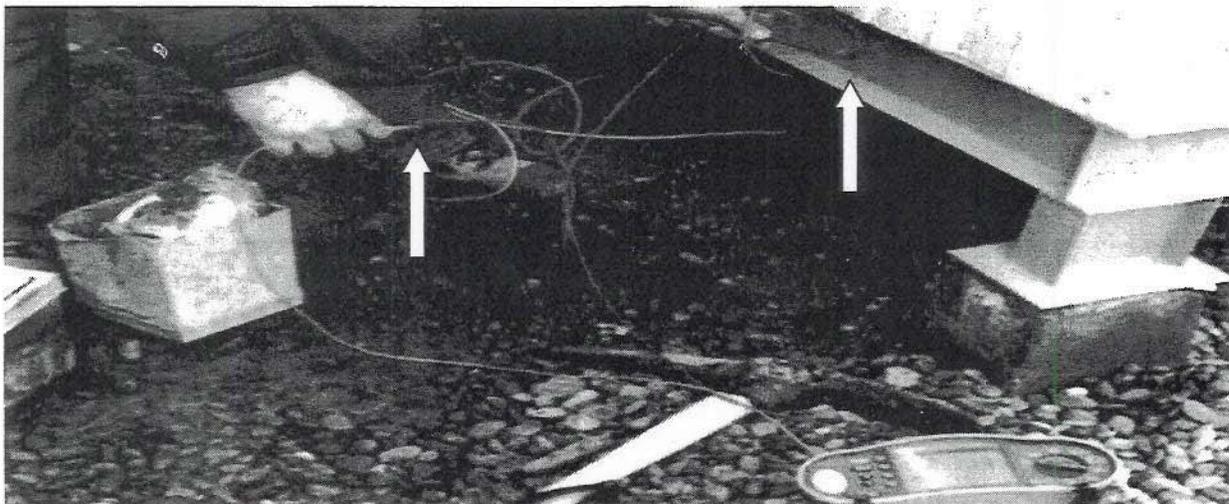
The first test performed was a voltage test between the wire left attached on the ground rod and the frame of the C.H.U. This would show us if a voltage potential existed between the two objects mentioned above. A negligible voltage was registered on the Fluke 1653B Multi-meter used for the test. This result is consistent with a correctly wired electrical system.

The test as performed with the Fluke Model 1653B Multi-meter. 12-Jan-2009 1545  
The arrows show the testing points.

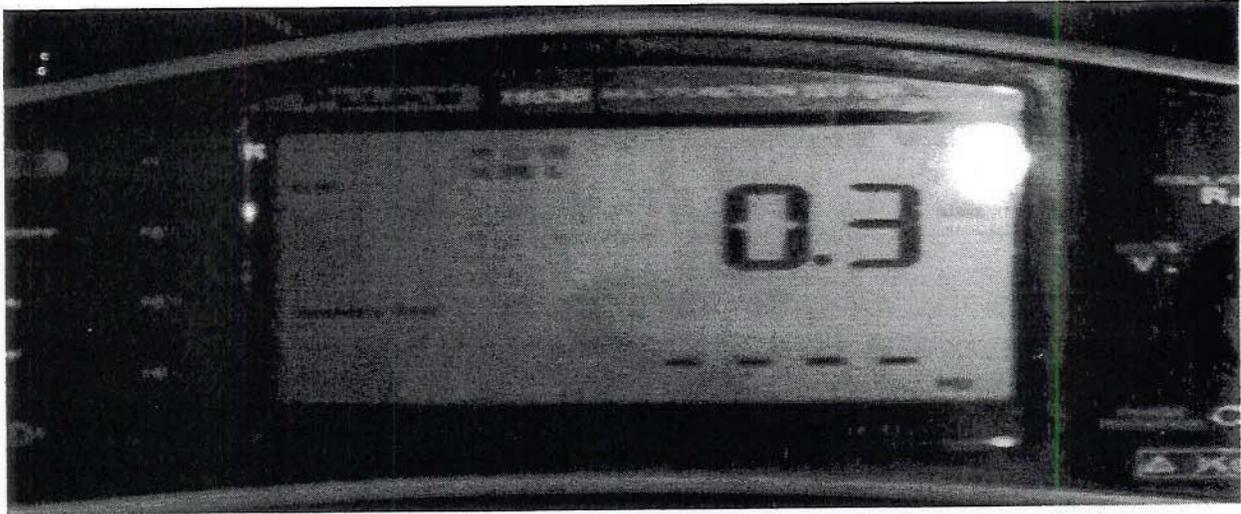
The results of the voltage test. 12-Jan-2009 1545

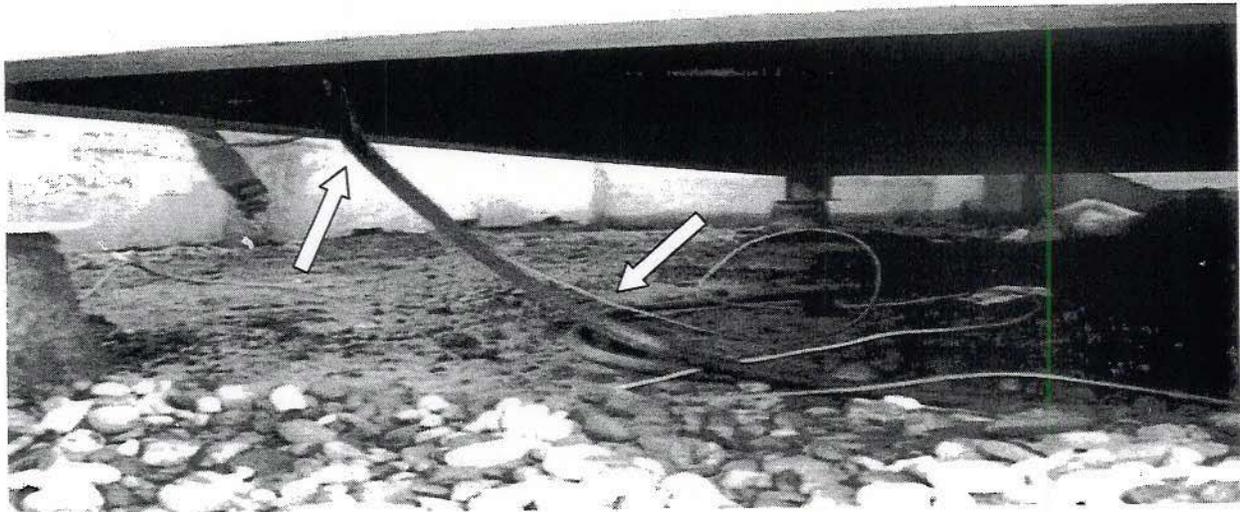
After this was done, a visual inspection of the feeder cable to the Containerized Housing Unit (C.H.U.) was inspected for possible cuts or abrasions from the pick-axe. The cable was closely scrutinized from the point of entry to the C.H.U. and, to the point where the cable becomes buried under the C.H.U. No cuts or any other noticeable abrasions could be found.

The arrows point to the feeder cable and to the equipment grounding conductor for the C.H.U.  
12-Jan-2009 1600

After the visual inspection of the cable, the equipment grounding conductor was traced back to the distribution panel (b)(2)High. This conductor was added by the O & M after the C.H.U.'s electrical system was incorrectly installed by the subcontractor (TRANS-ATLANTIC). This is

an acceptable means of repair. The conductor is in close proximity to the feeder cable, which is actually buried under all the other C.H.U.'s in the area. This is compliant to the British Standards for the TN-C-S Electrical System. The investigation then proceeded to distribution panel number - (b)(2)High

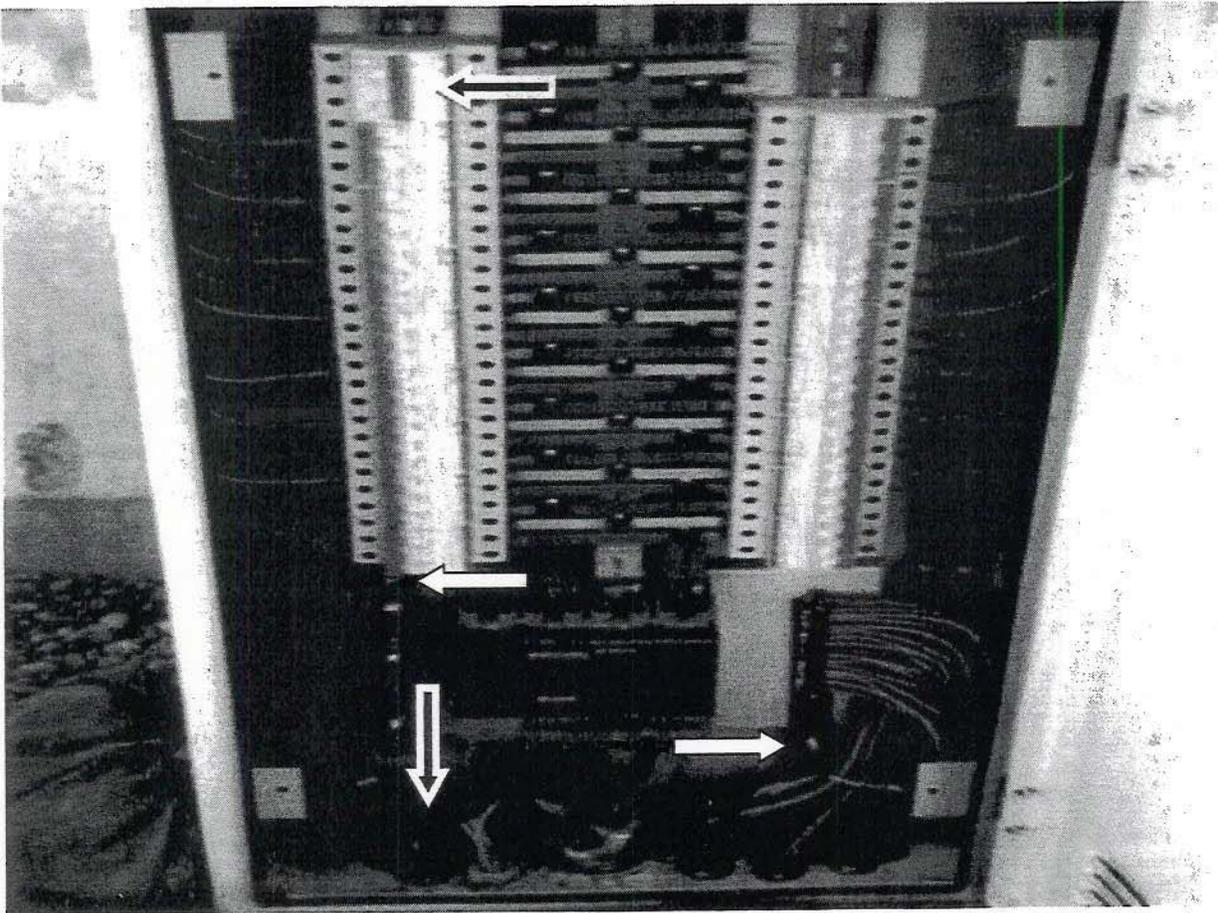
Distribution panel number - (b)(2)High 12-Jan-2009 1615

The distribution panel was opened and the dead-front was removed to expose the internal wiring components of the panel. The panel was found to be correctly bonded and grounded.

The white arrows point to where the distribution panel is bonded. The black arrow at the top of the photo points to the breaker that provides power to C.H.U. # - 16K. The red arrow points to the feeder cable for the C.H.U. where the incident occurred.

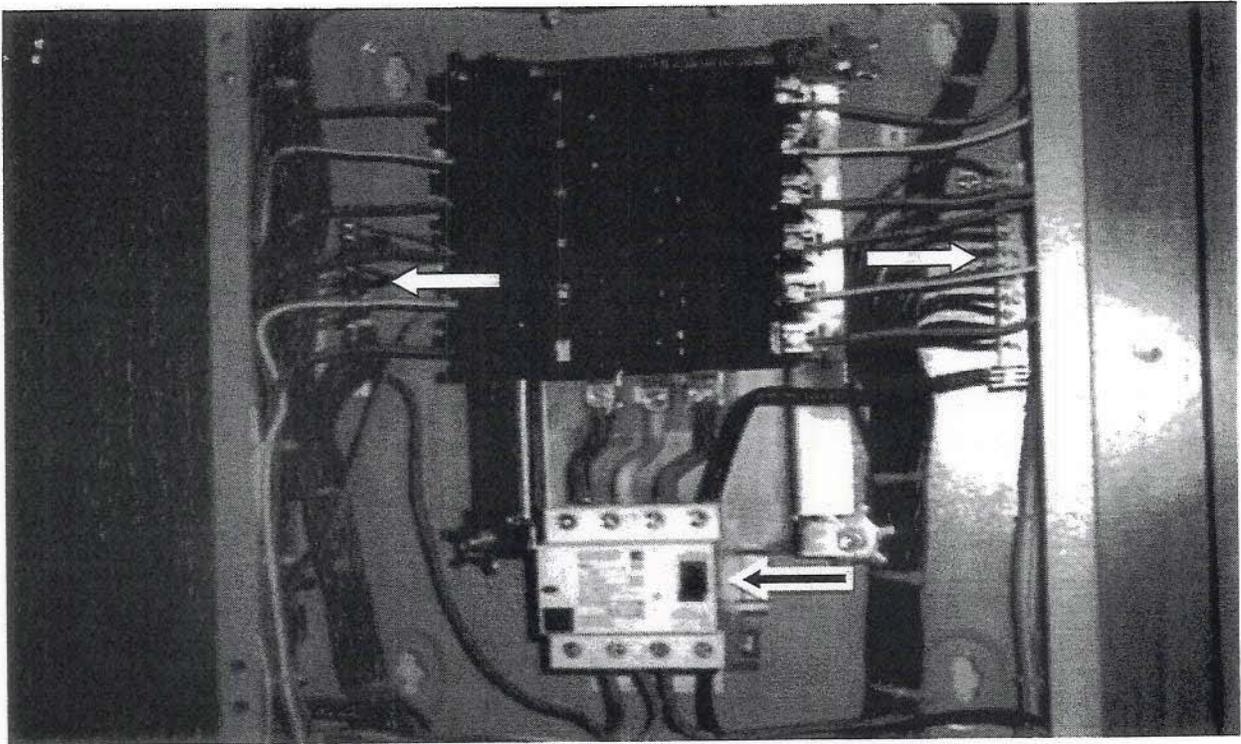
C.H.U. # - 16K Subpanel 12-Jan-2009 1630

The white arrows point to the separation of the neutral and equipment grounding conductors as required for the British Standards 7671 – TN-C-S System. The black arrow points to the main circuit breaker. This breaker is an R.C.D. type. The trip rating on the R.C.D. breaker is 30 mA. The R.C.D. tripped within its designed current level and time frame. (24 mA & 17.6 mS)

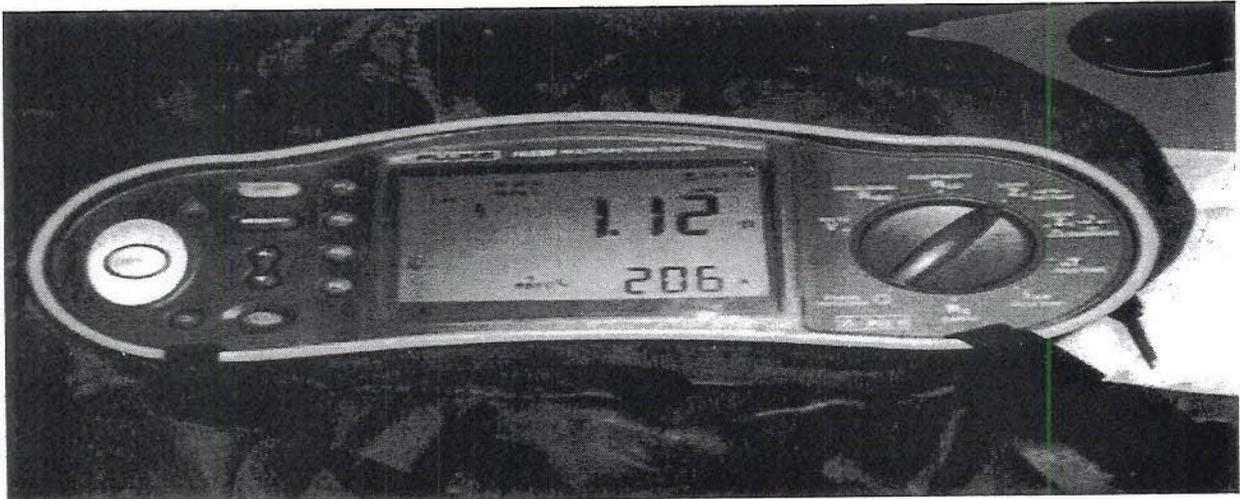
Loop impedance test results for C.H.U. # - 16K 12-Jan-2009 1645

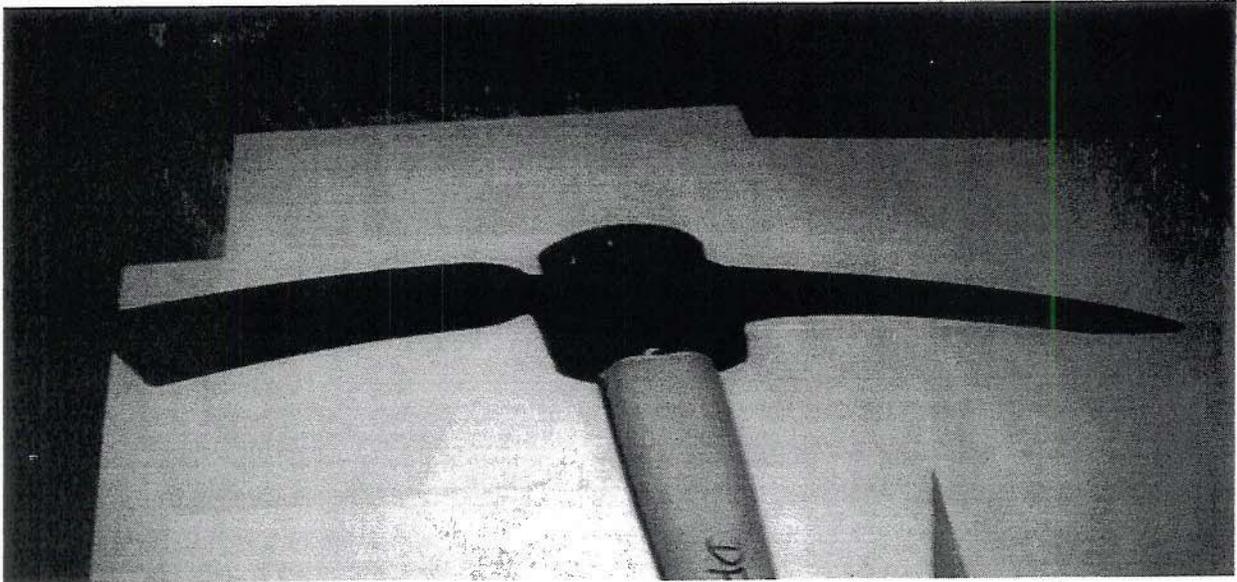
The last area investigated by the Task Force Safe Electrical Inspections Team was the pick-axe that was being used by the injured person when the incident happened. The pick-axe was taken back to the office and sprayed off with water. No evidence of accidental electrical contact could be found on the tool.

The pick-axe from the scene. The handle is made of fiberglass. 12-Jan-2009 1700
