**MULTI-NATIONAL FORCES-IRAQ
TASK FORCE SAFE – STANDARDS & INSPECTION TEAM**

Subject: Shock video narrative.

GROUNDING AND BONDING VIDEO EXPLANATION

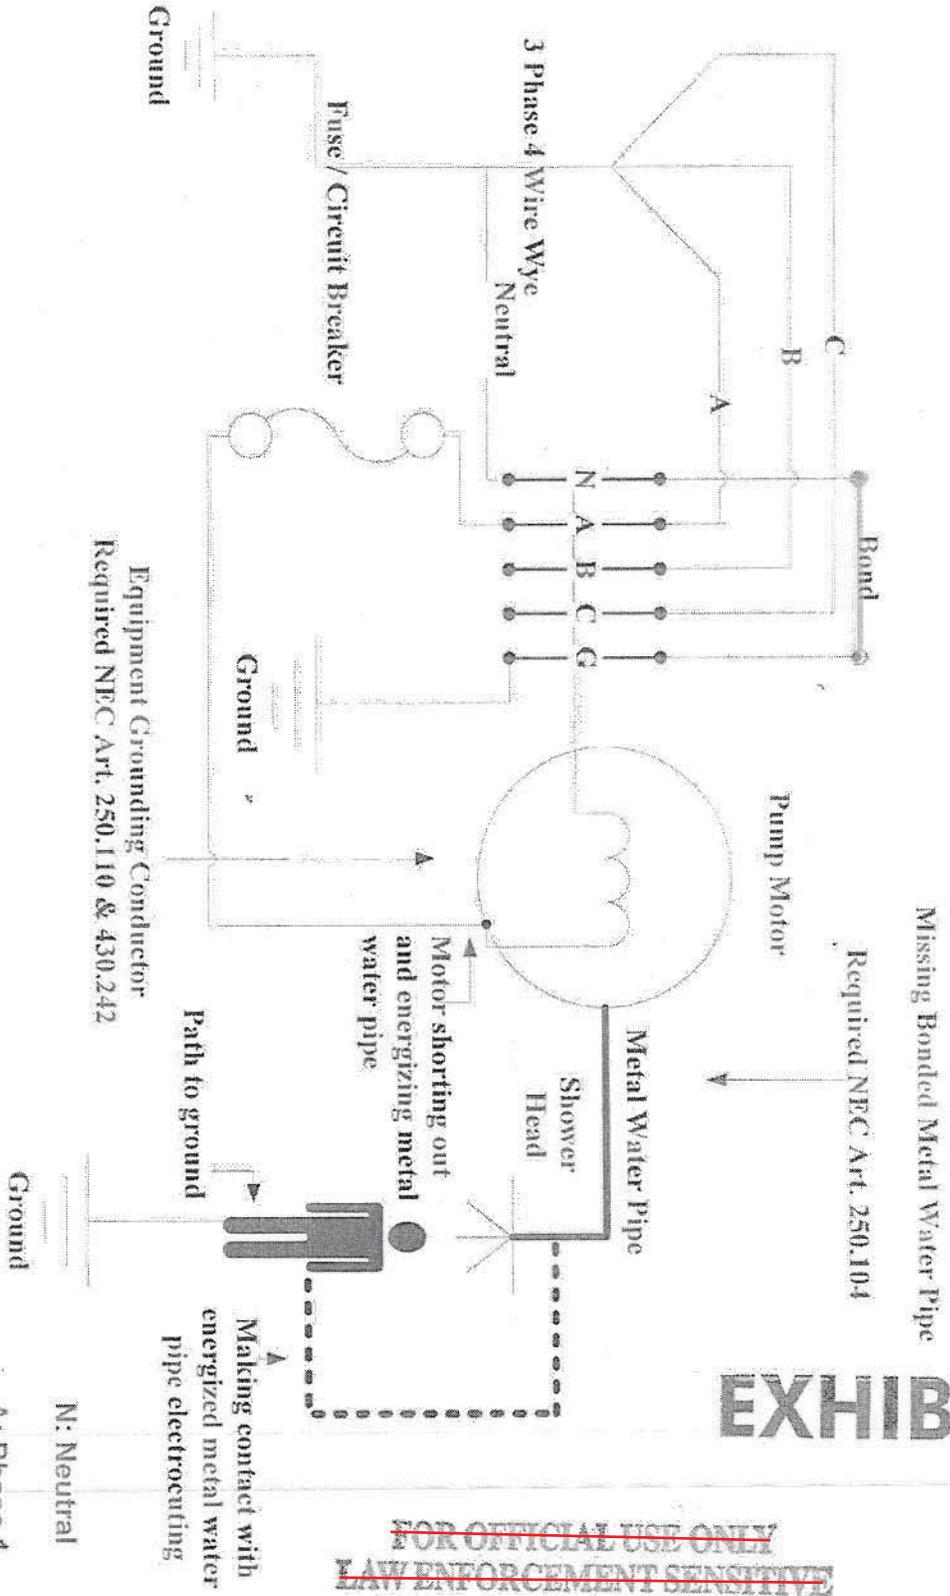
Not Properly Grounded & Bonded System

In this video (b)(3), (b)(6) explains that the bonding of the metal water pipe back to the source did not take place (b)(3), (b)(6) also notes that the equipment grounding conductor that was run to the water pump was cut off in the motor termination box. These are the two major electrical code violations which contributed to the soldier's death.

When the wire in the pumps motor termination box shorted to the pump housing, the wire carrying 230 volts energized the motor and the metal water pipe. Because there was no bonding and no equipment grounding conductor, the soldier's body became the conductor back to the source which caused the unfortunate death.

Missing Bonded Metal Water Pipe
Required NEC Art. 250.104
