OBJ LEFTY GROVE—EXTORTION 17 CRASH

As of 092300z AUG 11

5 AUG 2011, Sayedabad District, Wardak Province

—EXTORTION 17 CRASH

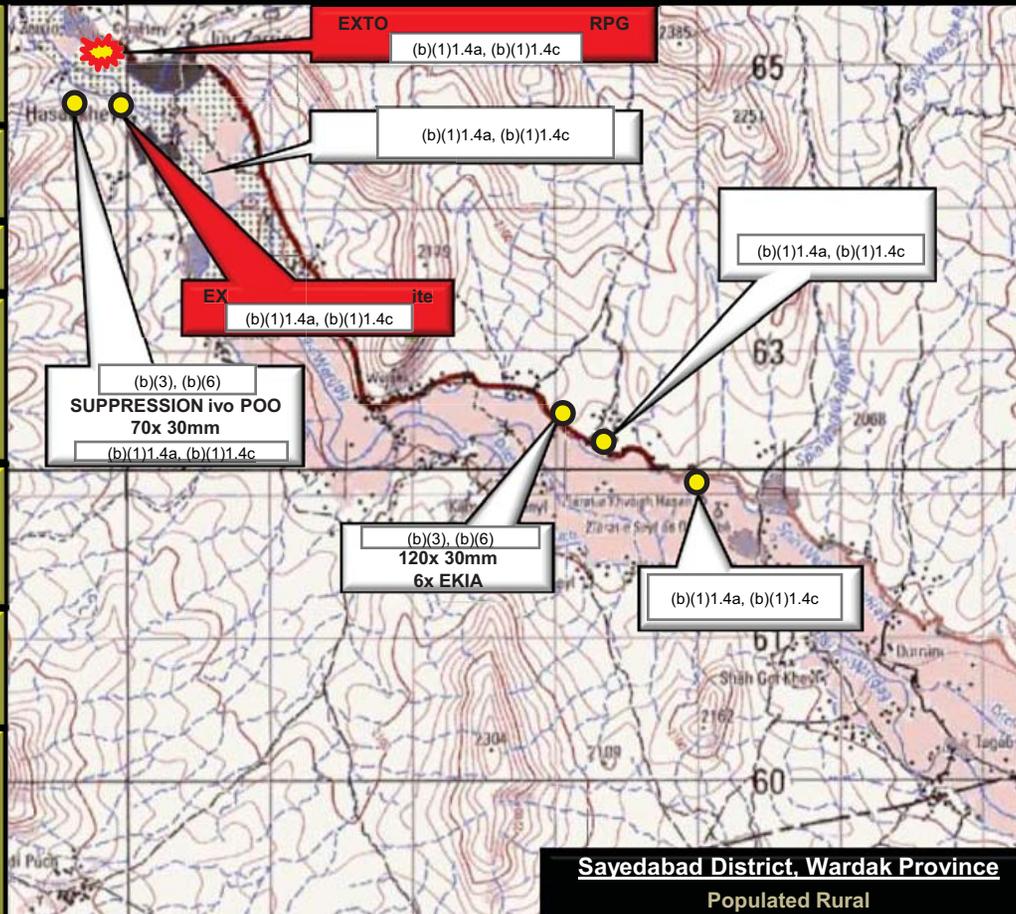
The Assault Force (AF), (b)(1)1.4a, (b)(1)1.4c conducted a HAF raid with an infil HLZ approx 2km from the OBJ. Upon infil, AF PID'd armed MAMs demonstrating hostile intent and engaged with AWT in self-defense, resulting in 6 x EKIA.

While moving to contain the OBJ, AF reported multiple MAMs squirting from the target compound and requested Immediate Reaction Force (IRF) support to interdict.

At 2130z the IRF was directed to infil and interdict the squirters that had moved Northwest of the objective area.

At 2209z, while enroute to contain suspected combatants, the IRF acft (1 x CH-47 callsign Extortion 17), escorted by AC-130 and AWT, was struck from a suspected RPG approximately 4 km from OBJ Lefty Grove. The acft had 38 personnel onboard. Fires and ISR assets were immediately shifted to the site with no reports of movement.

Due to location and enemy situation, AF moved by foot 3.9 km to secure the crash site. AF arrived at 0015z and immediately secured the area. TF Pathfinder (RC-East Quick Reaction Force) infil'd to HLZ, linked up shortly after at the crash site, and assisted TM (b)(1)1.4a, (b)(1)1.4c in securing the immediate area.

AF arrived at the crash site at 0015z and immediately secured the area. The AF reported 6 x FKIA initially, but had to pull back from the site due to secondary explosions and burning wreckage. At 0328z, GFC assessed no survivors.

At 0726z, TF (b)(1)1.4a, (b)(1)1.4c the BSO, linked up with the AF to lead in evacuation of the remains and debris. Remains of 38 x FKIA were recovered. Throughout the day, the AF and BSO element were provided with multiple aerial resupplies and EOD / CSAR pax / equipment in order to continue recovery operations. The AF was replaced by a TM (b)(1)1.4a, (b)(1)1.4c early on 7 AUG 11. TM (b)(1)1.4a, (b)(1)1.4c exfiltrated crash site at 091530z AUG 11.

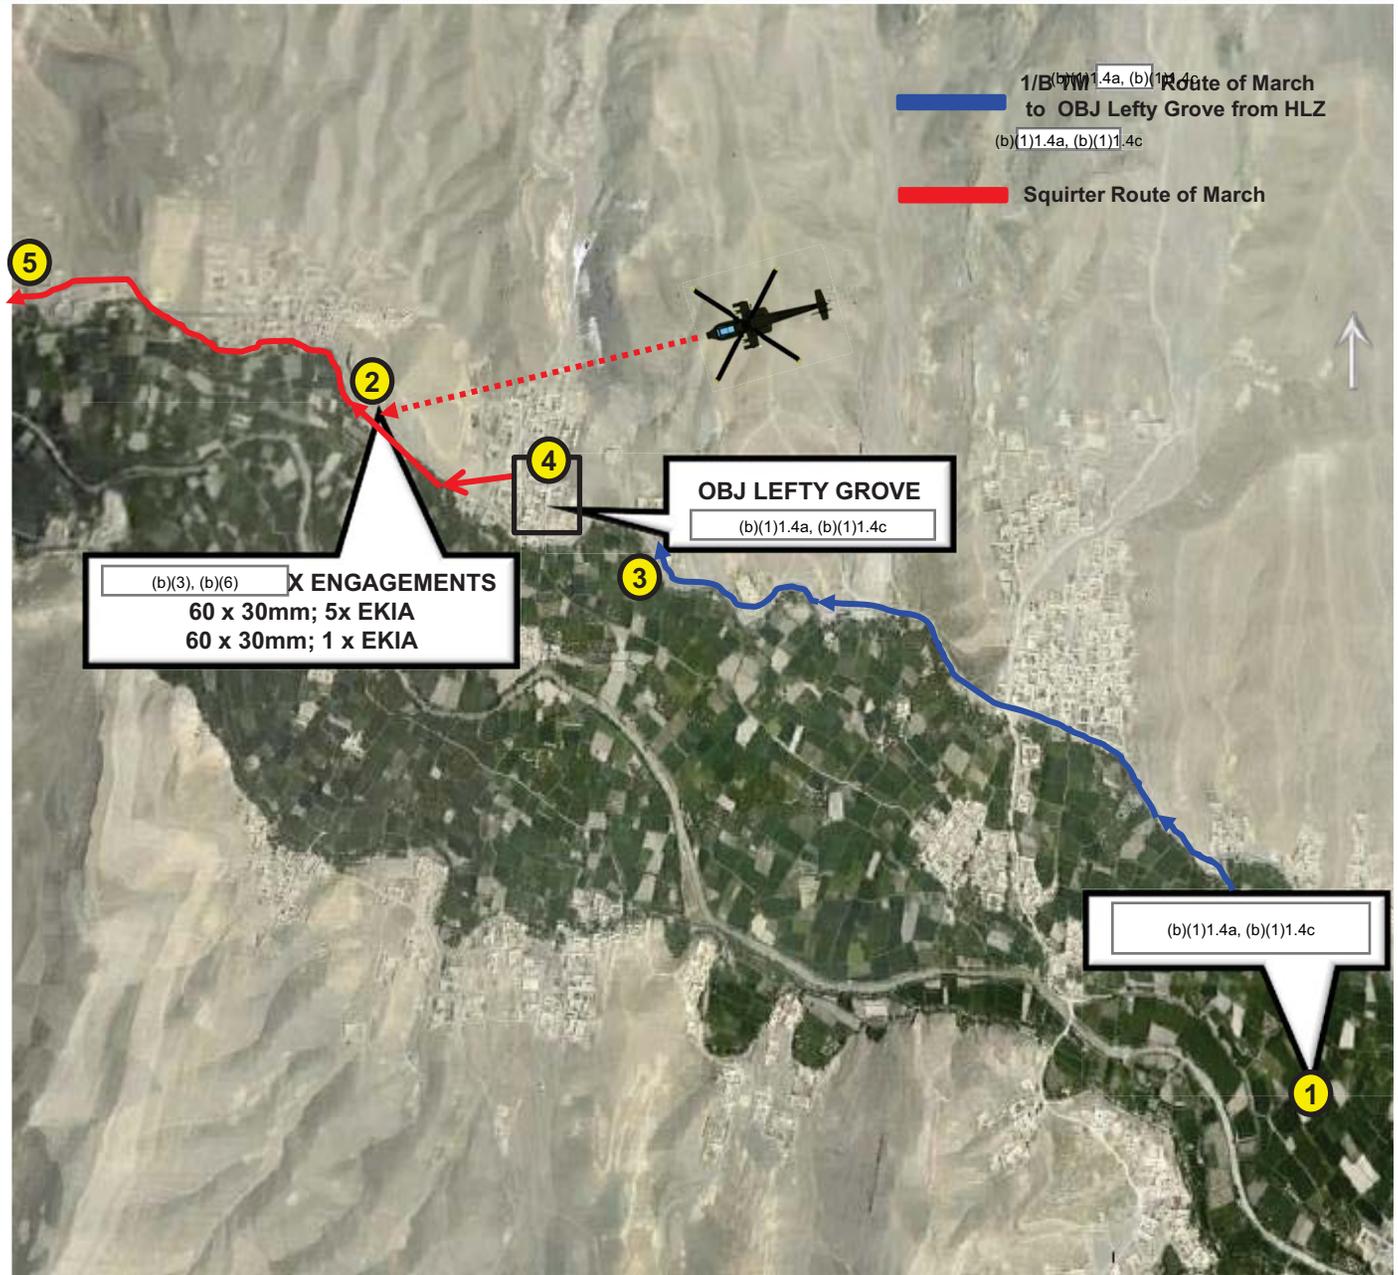
EXTORTION 17 CRASH—SEQUENCE OF EVENTS (1/3)

AF Timeline on OBJ Lefty Grove

1
1831Z: AF (b)(1)1.4a, (b)(1)1.4c set infil complete, HLZ (b)(1)1.4a, (b)(1)1.4c

2
1901Z: (b)(3), (b)(6) AWT, PID'd 8 x MAMs w/ RPGs and AK-47s demonstrating hostile intent.
1905Z: (b)(3), (b)(6) cleared hot by (b)(3), (b)(6) (JTAC).
1910Z: AWT engaged 8 x INS w/ 60 x 30mm. Result is 5 x EKIA. 1 x INS remained, multiple INS squirted Northwest along the road.
1917Z: (b)(3), (b)(6) requested (b)(3), (b)(6) immediately re-attack original strike area. Result was 1 x EKIA.

3
1924Z: AF reached Objective Rally Point (ORP).

4
1950Z: AF commenced callout on 10 series buildings.
2133Z: 10 series clear; Bldg 69 clear; AWT strike area SSE = 6xEKIA, 2xAK-47, 1x RPG, 6 x frag grenades.

5
2100Z: (b)(3), (b)(6) reported that squitters from OBJ area have stopped and entered a compound IVO (b)(1)1.4a, (b)(1)1.4c.
2130Z: the IRF was directed to infil and interdict the squitters that had moved Northwest of the objective area.

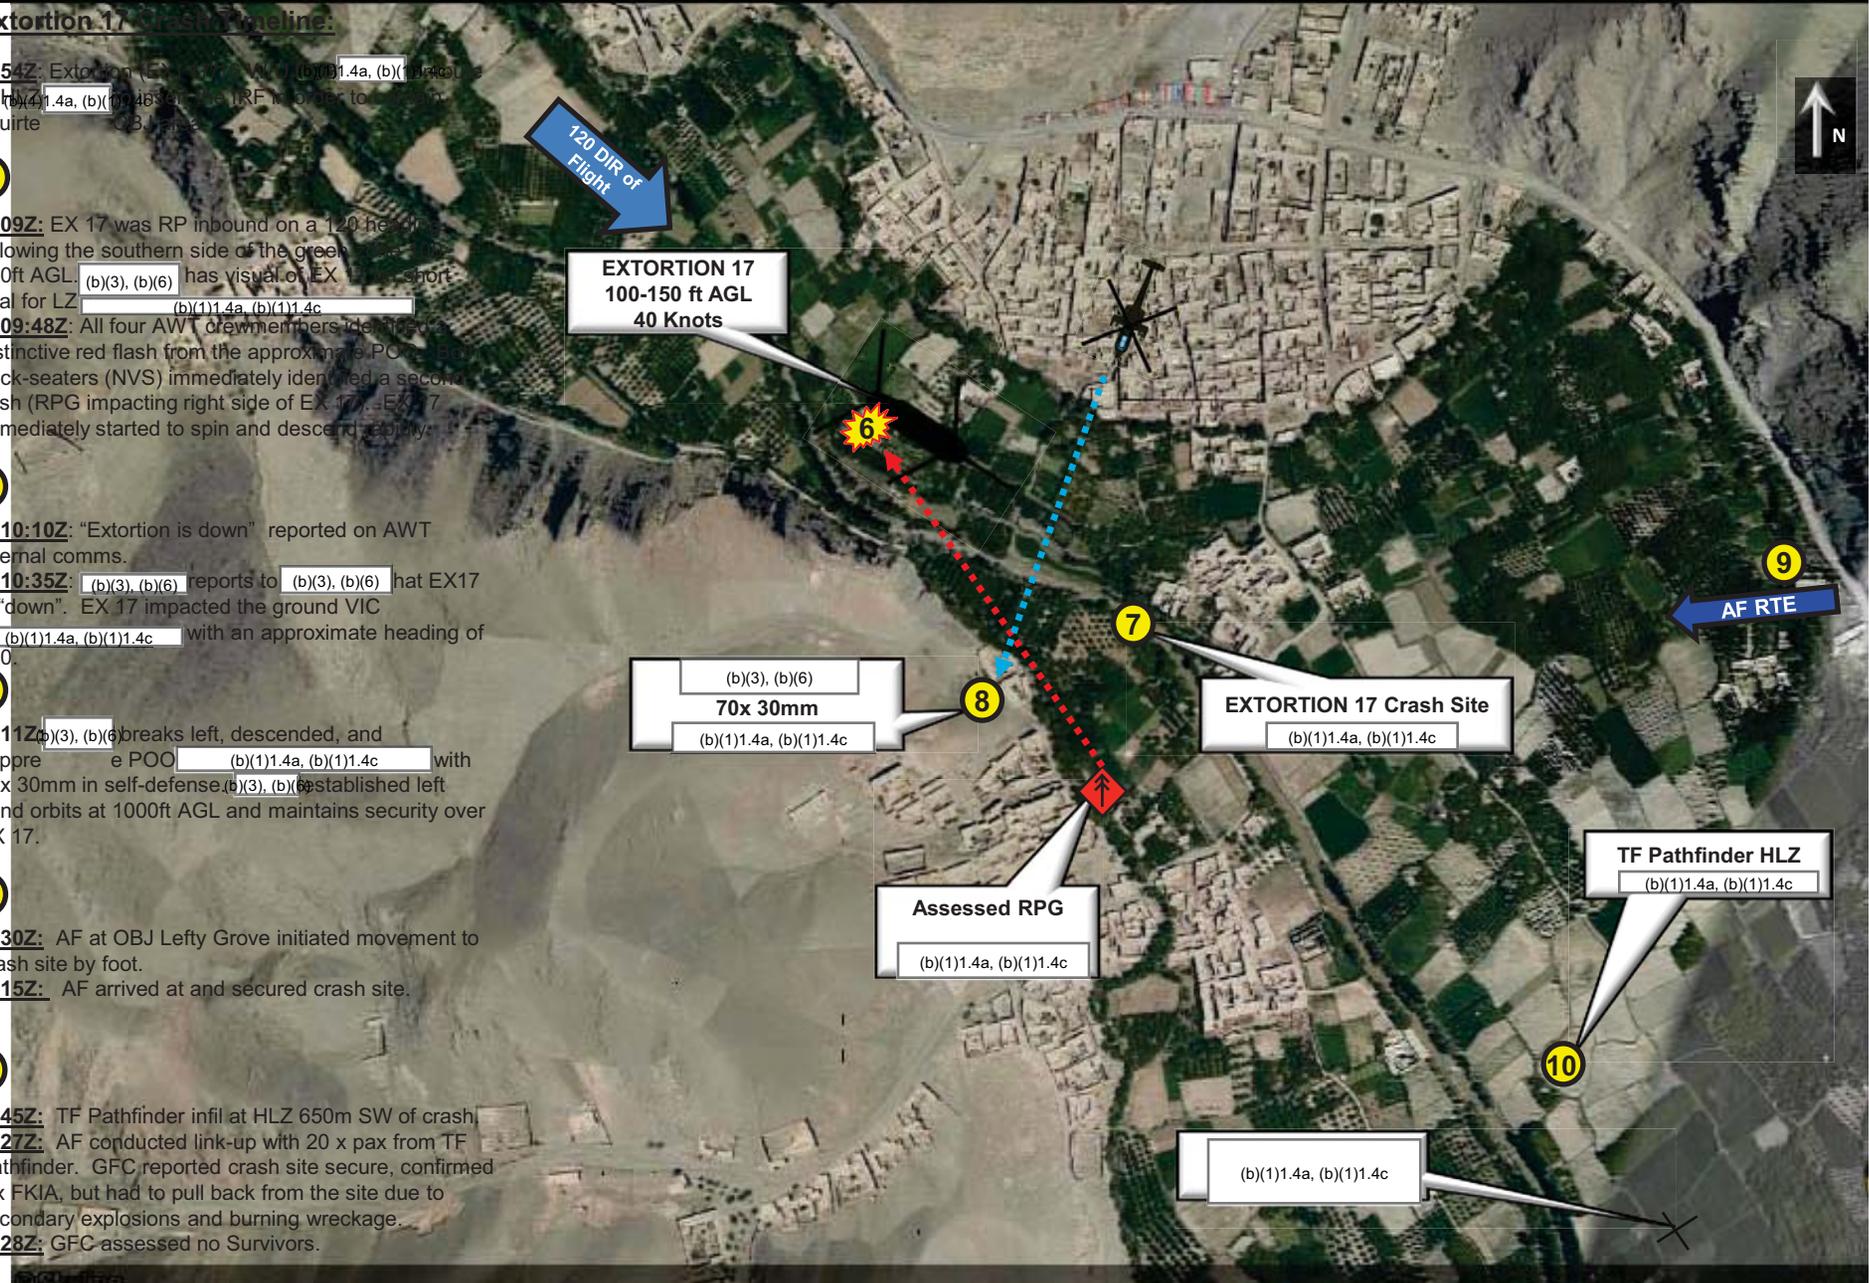
EXTORTION 17 CRASH—SEQUENCE OF EVENTS (2/3)

Extortion 17 Crash Timeline:

2154Z: Extortion (EX 17) AWT (b)(3), (b)(6) (b)(1)1.4a, (b)(1)1.4c to (b)(1)1.4a, (b)(1)1.4c, (b)(1)1.4b, (b)(1)1.4c IRF in order to (b)(1)1.4a, (b)(1)1.4c squirrel (b)(3), (b)(6)

2209Z: EX 17 was RP inbound on a 120 heading following the southern side of the green valley at 100-150ft AGL. (b)(3), (b)(6) has visual of EX 17 in short final for LZ (b)(1)1.4a, (b)(1)1.4c

2209:48Z: All four AWT crewmembers identified a distinctive red flash from the approximate POB. Two back-seaters (NVS) immediately identified a second flash (RPG impacting right side of EX 17). EX 17 immediately started to spin and descend rapidly.

2210:10Z: "Extortion is down" reported on AWT internal comms.

2210:35Z: (b)(3), (b)(6) reports to (b)(3), (b)(6) that EX17 is "down". EX 17 impacted the ground VIC (b)(1)1.4a, (b)(1)1.4c with an approximate heading of 330.

2211Z: (b)(3), (b)(6) breaks left, descended, and suppressed the POB (b)(1)1.4a, (b)(1)1.4c with 70x 30mm in self-defense. (b)(3), (b)(6) established left hand orbits at 1000ft AGL and maintains security over EX 17.

2230Z: AF at OBJ Lefty Grove initiated movement to crash site by foot.

0015Z: AF arrived at and secured crash site.

2345Z: TF Pathfinder infil at HLZ 650m SW of crash.

0027Z: AF conducted link-up with 20 x pax from TF Pathfinder. GFC reported crash site secure, confirmed 6 x KIA, but had to pull back from the site due to secondary explosions and burning wreckage.

0328Z: GFC assessed no Survivors.

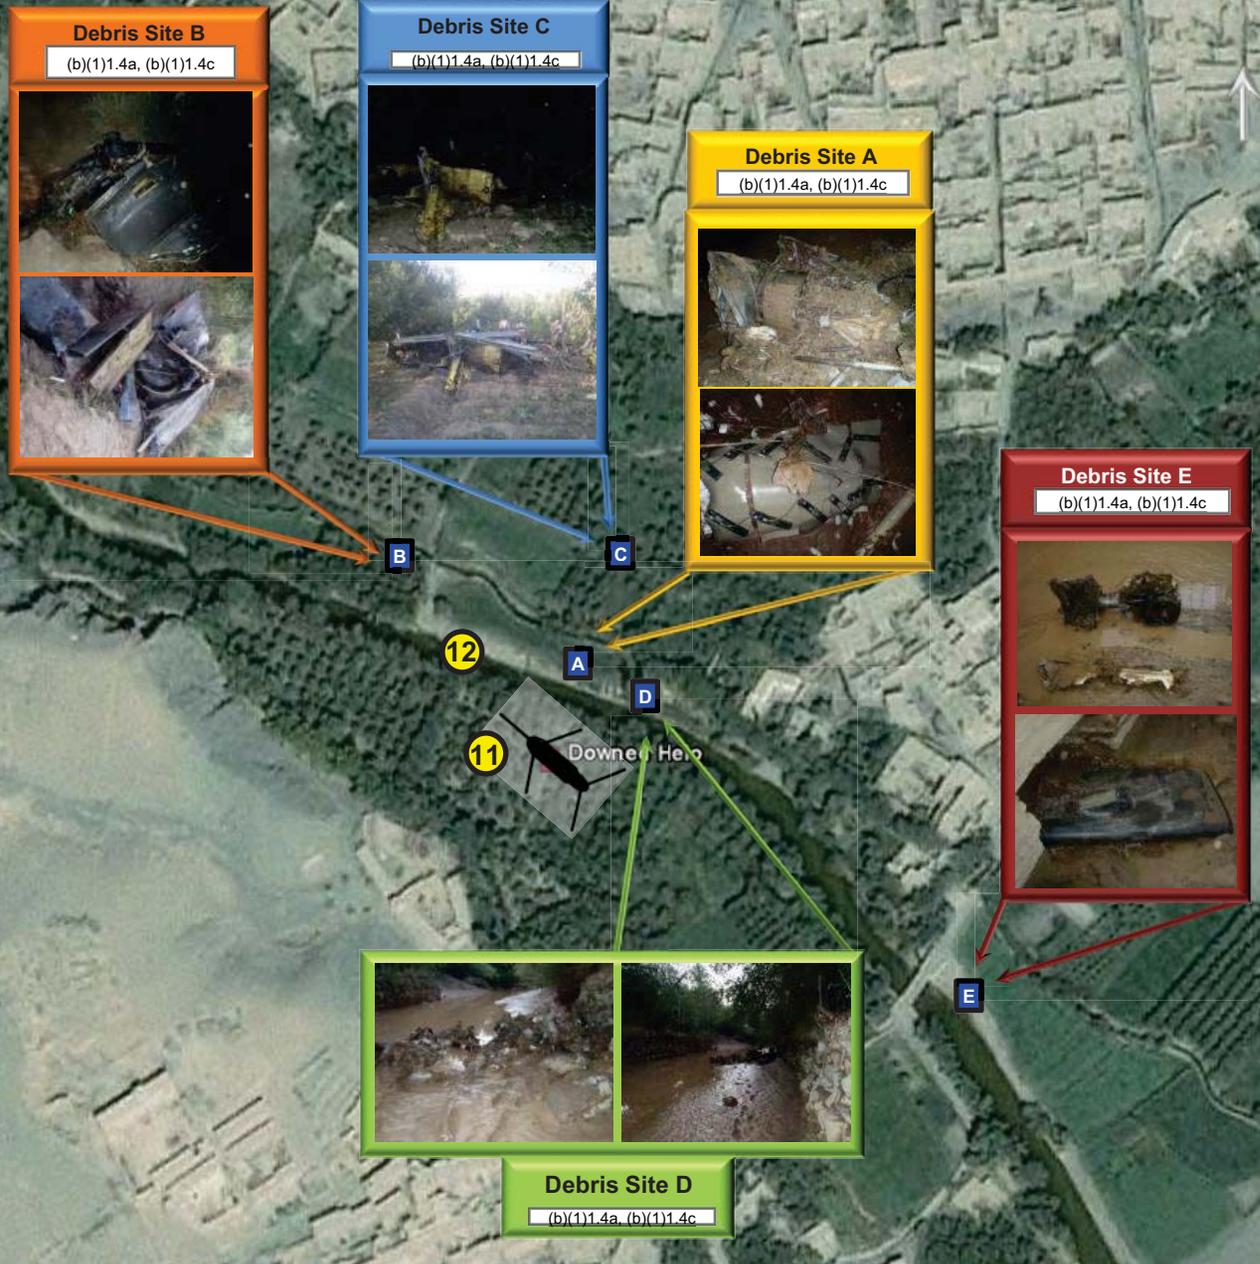
EXTORTION 17 CRASH—SEQUENCE OF EVENTS (3/3)

Recovery Timeline:

0721z: BSO (b)(1)1.4a, (b)(1)1.4c pickup complete with TF (b)(1)1.4a, (b)(1)1.4c at crash site. Crash site was centrally located in vicinity of (b)(1)1.4a, (b)(1)1.4c at this time.

1155z: BSO departs crash site with the remains of a 38 x FKIA. TF Pathfinder and T (b)(1)1.4a, (b)(1)1.4c remain to continue site sanitation and provide security.

Throughout the afternoon of 6 AUG 11, heavy rains forced the BSO to delay multiple attempts to reinforce the crash site. Furthermore, the rains created a flash flood of up to 2 feet of rushing water that filled the riverbed, scattered debris, and ultimately delayed the site sanitation. The debris field is depicted in blocks A-E. The main fuselage, nose, and 2 x engines were found in the riverbed (site A).

2230z: TM (b)(1)1.4a, (b)(1)1.4c CSAR element, and EOD linked up with TM (b)(1)1.4a, (b)(1)1.4c at the crash site.

2253z: RIP completed; (b)(1)1.4a, (b)(1)1.4c assumed security and sanitization duties with TF Pathfinder and (b)(1)1.4a, (b)(1)1.4c.

Throughout 7 and 8 AUG 11, (b)(1)1.4a, (b)(1)1.4c and enablers continued to destroy and break apart debris using torches, saws, thermite grenades, and high explosives. Multiple resupplies were conducted via air delivery and by (b)(1)1.4a, (b)(1)1.4c. Inclement weather delayed the clearing and sanitization efforts.

081405zAUG11: Vast majority of remaining debris and recovered items were taken away via a BSO convoy.

091745zAUG11: Extortion 17 Crash Site deemed 100% clean, (b)(1)1.4a, (b)(1)1.4c removed all remaining debris away and all friendly forces have RTB.

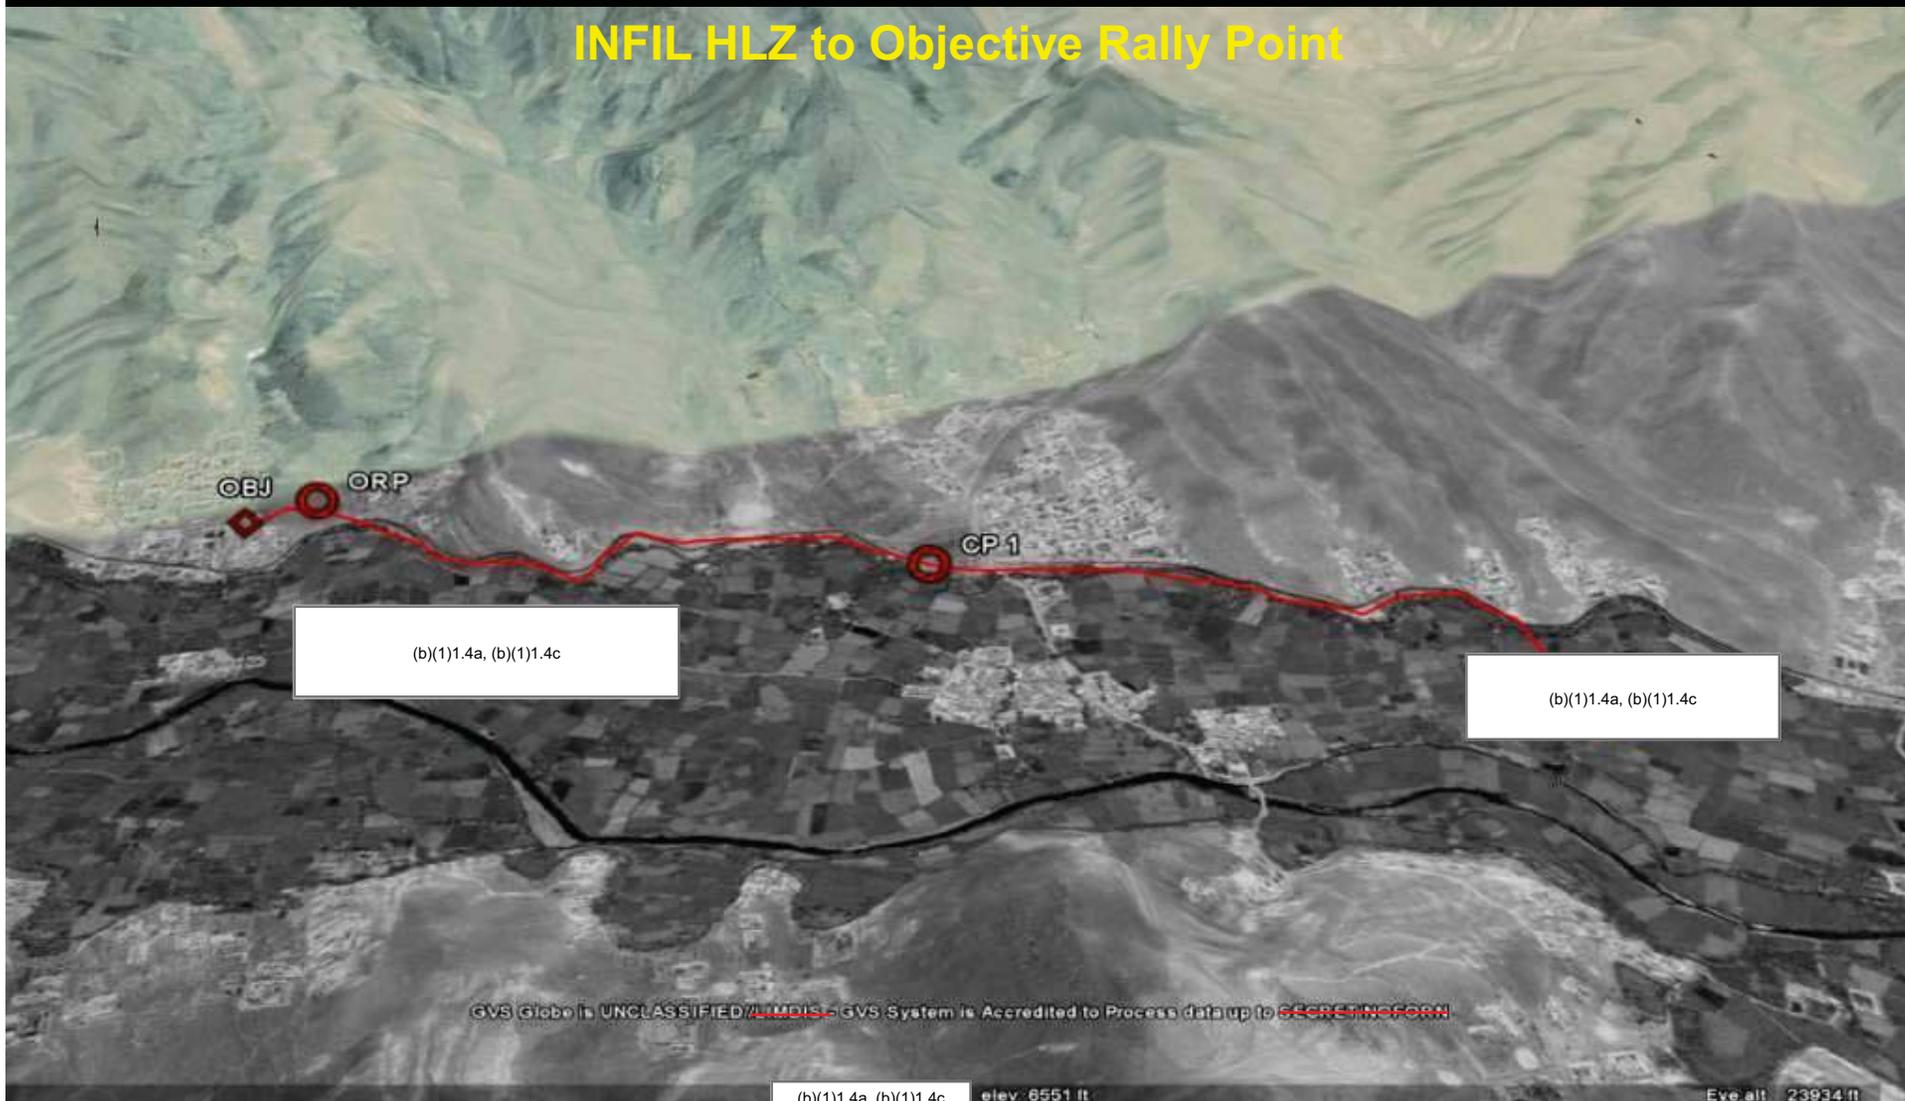
1/B OFFSET INFIL ROUTE (1/2)

INFIL HLZ to Objective Rally Point

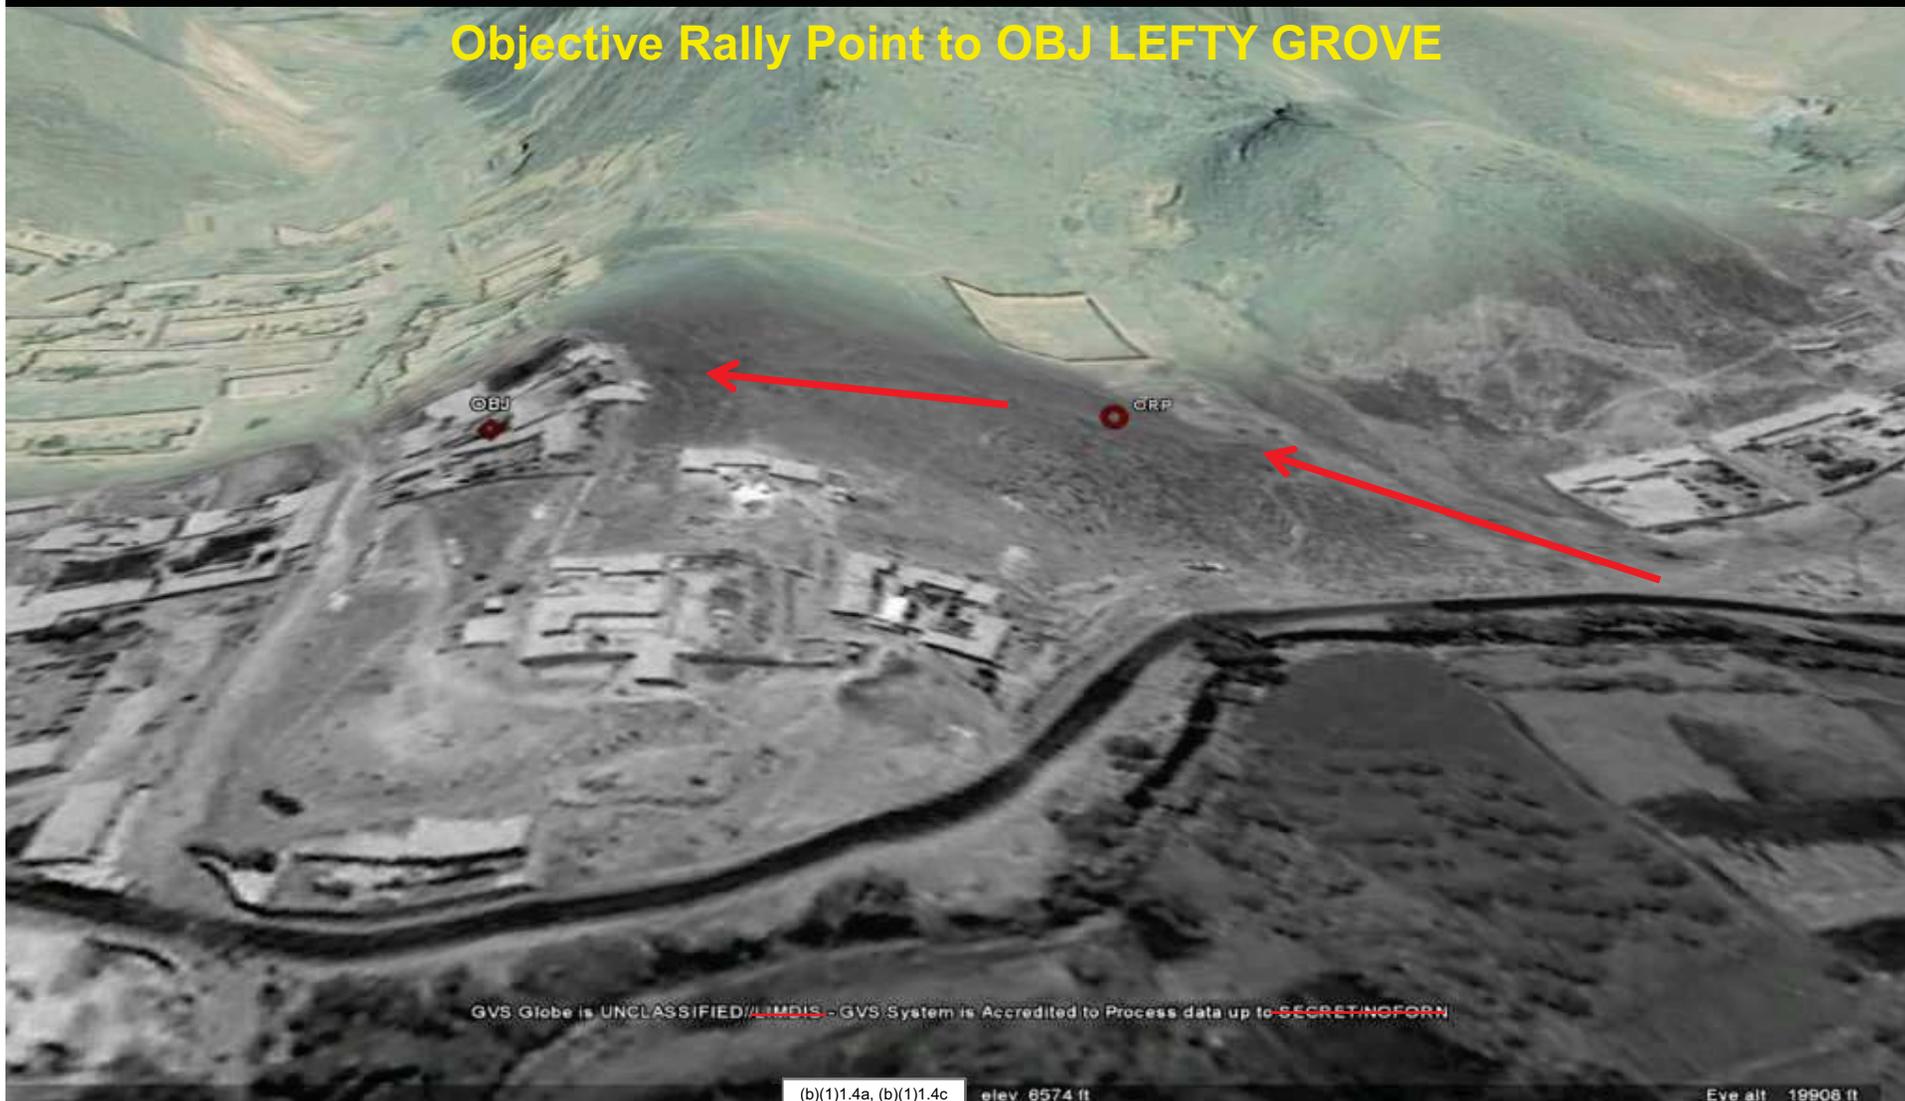
1/B OFFSET INFIL ROUTE (2/2)

Objective Rally Point to OBJ LEFTY GROVE
