FOB Iskandariyah, Iraq, (b)(2)High

Base Camp Master Plan

As of 7MAR05
Updated 26MAR05
Updated 17APR05

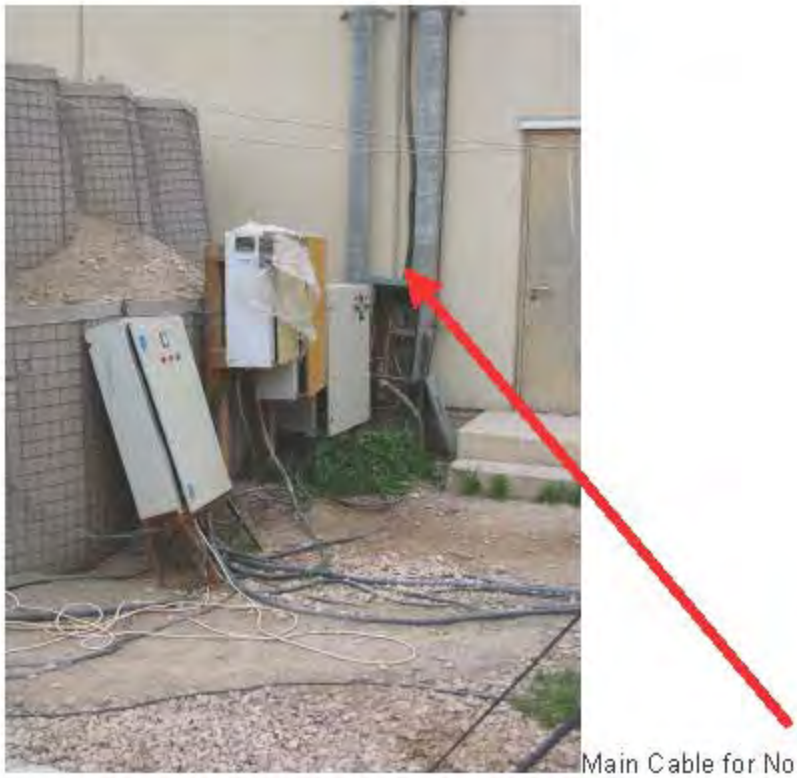
Main Cable for Northeast corner of FOB
