Recovered Bullets – ETT Compound

FOB Robinson

Bullets in custody of KAF CID Photographed at CID office 9 Apr 06

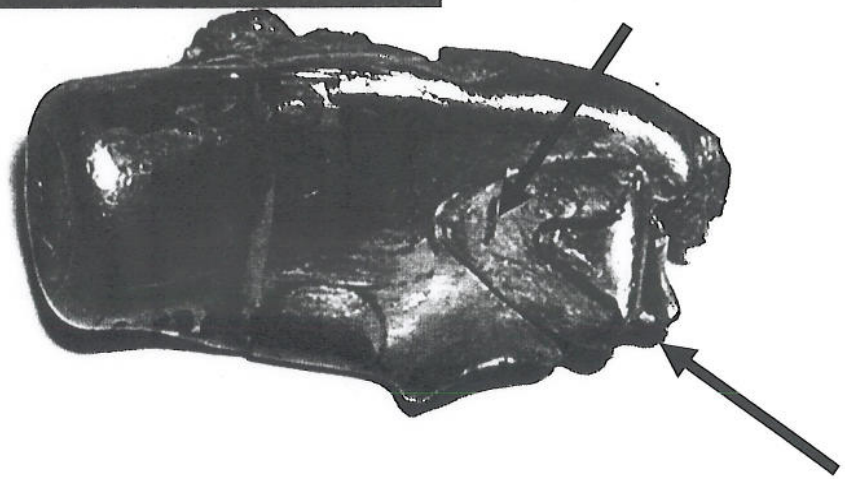
Bullet 1 "Side B": recovered from South side of the wall on the ETT rooftop, at approximately the same height as CPT (b)(6); (7)(c) hip GSW

Characteristics:

- Steel tip insert intact, folded over
- Indication of black tip

Characteristics indicative of 7.62x51mm NATO AP round

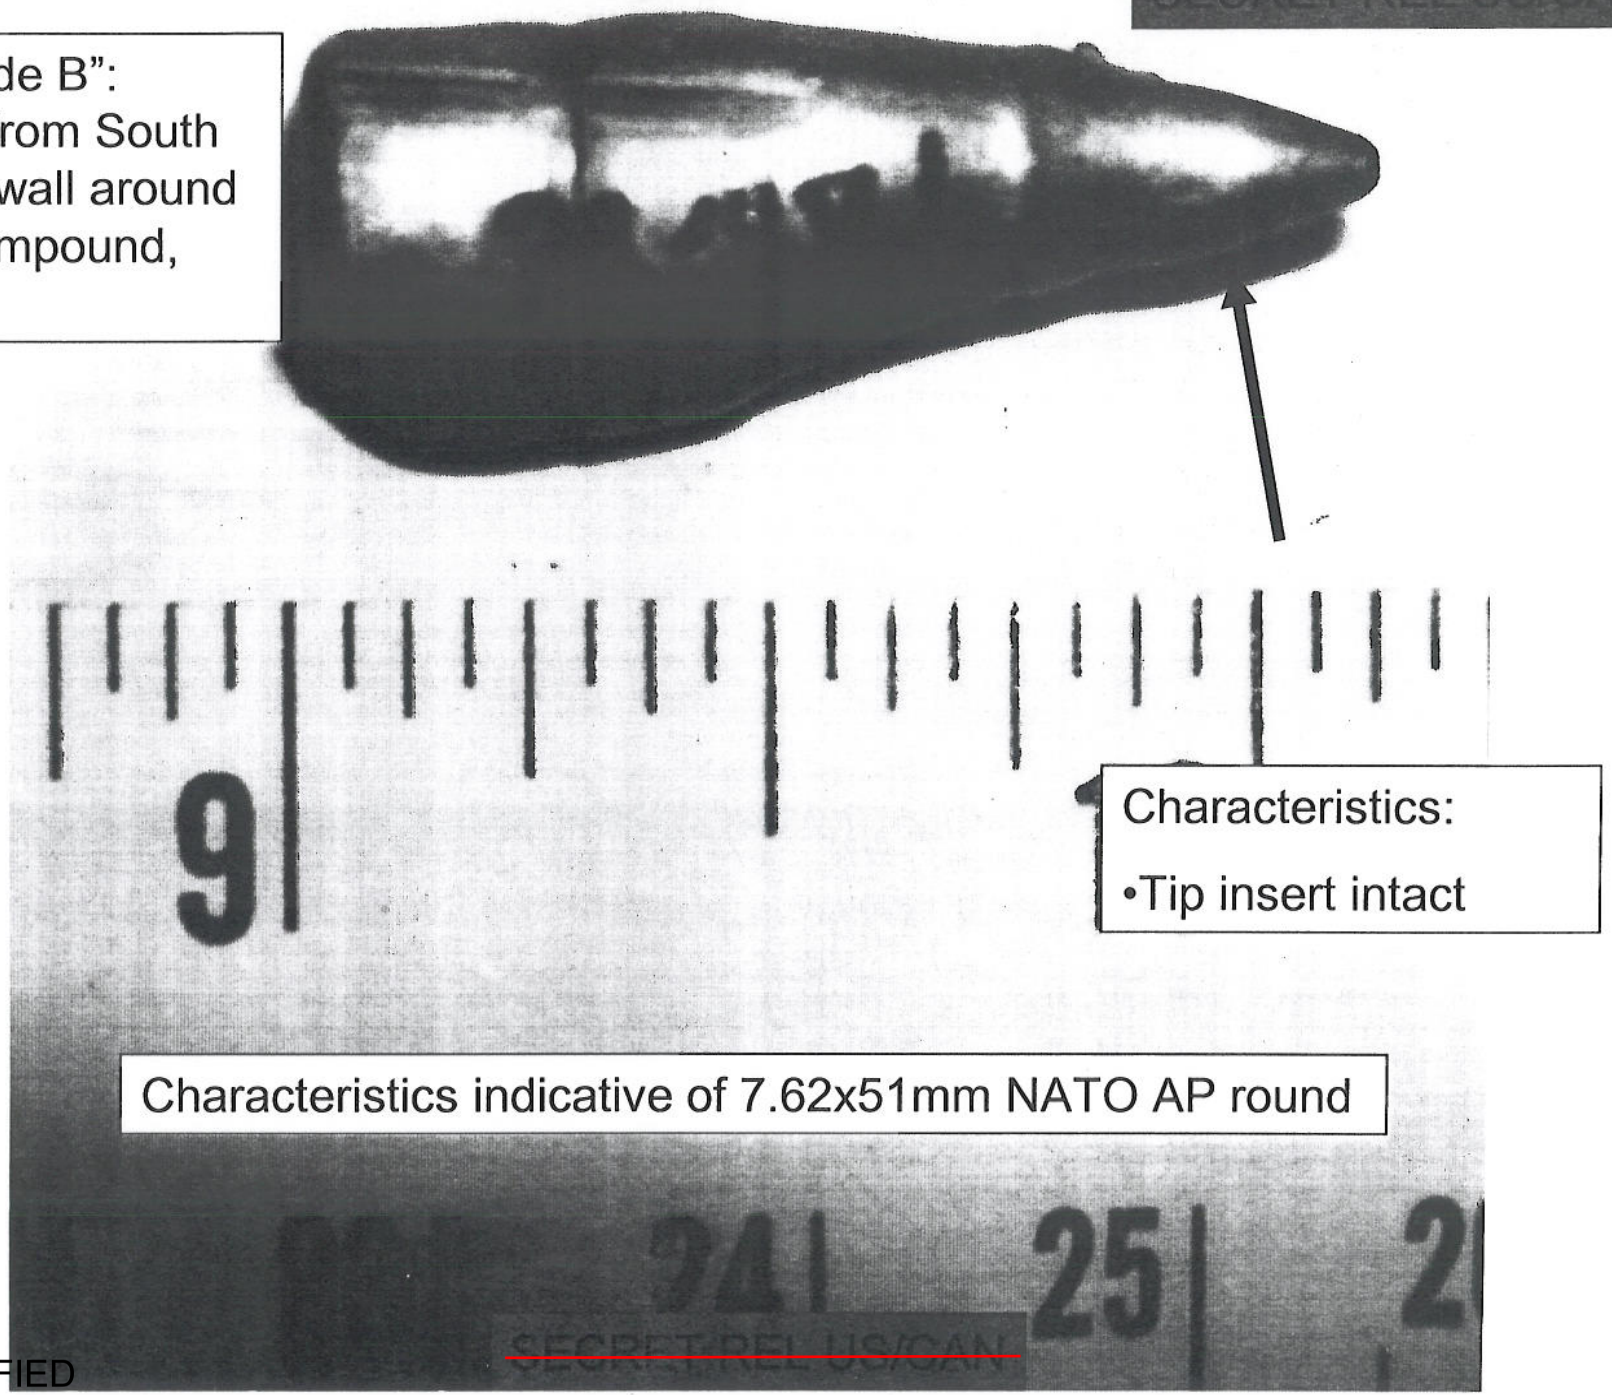
Bullet 2 “Side B”: recovered from South side of the wall around the ETT compound, near tent

Characteristics:

•Tip insert intact

Characteristics indicative of 7.62x51mm NATO AP round
