**MULTI-NATIONAL FORCES-IRAQ
TASK FORCE SAFE – STANDARDS & INSPECTION TEAM**

Subject: Shock video narrative.

GROUNDING AND BONDING VIDEO EXPLANATION

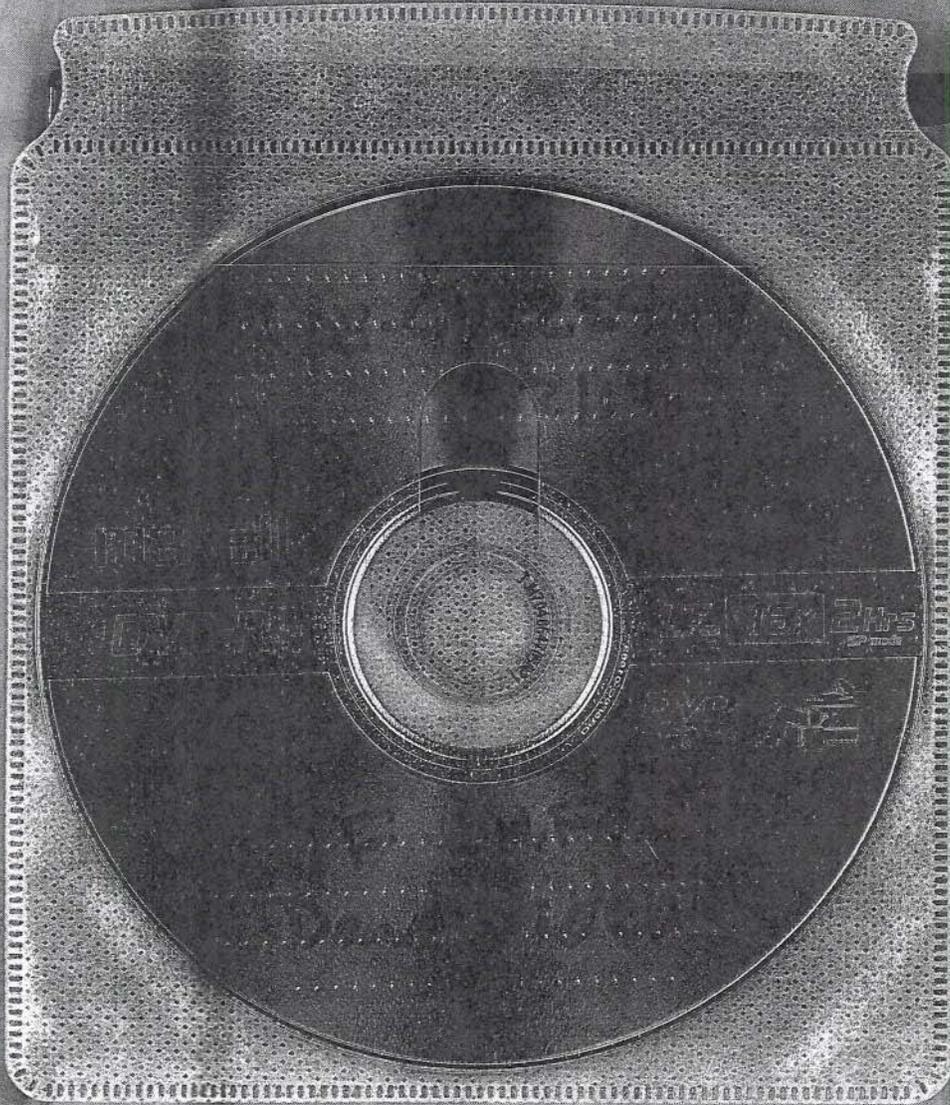
EXHIBIT 136

In this video (b)(3), (b)(6) explains that the bonding of the metal water pipe back to the source did not take place (b)(3), (b)(6) also notes that the equipment grounding conductor that was run to the water pump was cut off in the motor termination box. These are the two major electrical code violations which contributed to the soldier's death.

When the wire in the pumps motor termination box shorted to the pump housing, the wire carrying 230 volts energized the motor and the metal water pipe. Because there was no bonding and no equipment grounding conductor, the soldier's body became the conductor back to the source which caused the unfortunate death.

Missing Bonded Metal Water Pipe
Required NEC Art. 250.104
